DELAWARE RIVER BASIN,
LUBBERS RUN, SUSSEX COUNTY
NEW JERSEY.

CRANBERRY LAKE DAM NJ 00325

PHASE 1 INSPECTION REPORT
NATIONAL DAM SAFETY PROGRAM
DACW 61-79-C-0011

Rept. no. DAEN/NAP - 53842/NJ 00325-81/03
MARCH 1981

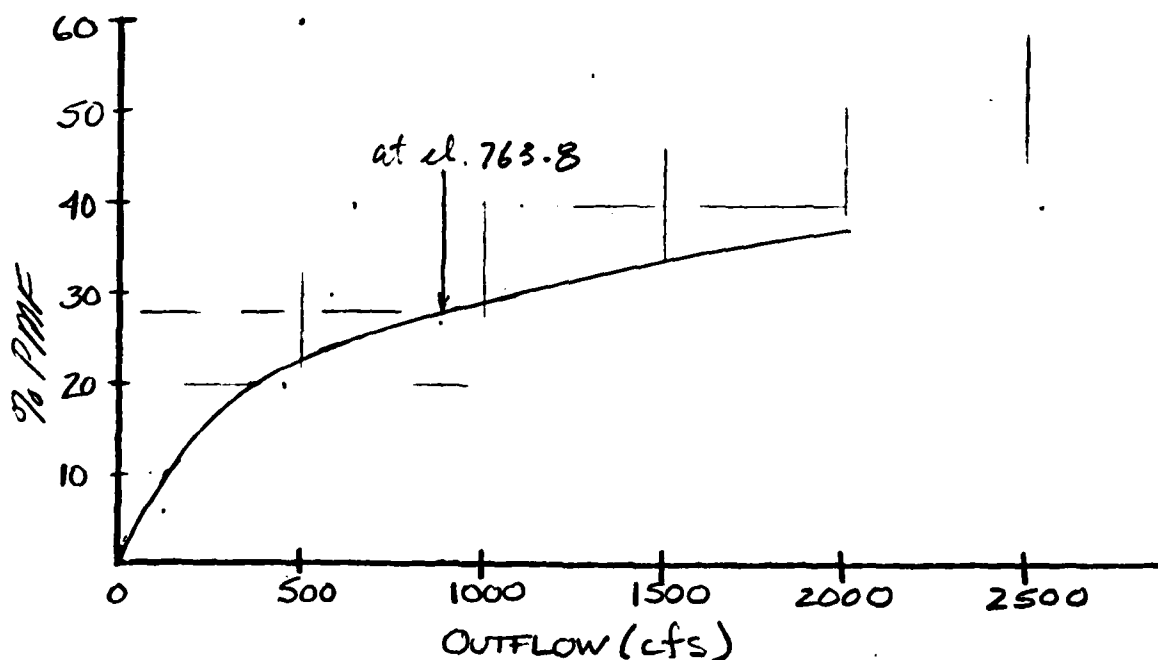
- 3) Dam overtops at elev. 763.8 with $Q = 894$
 \therefore dam can pass approx 28 % of PMF.
